SUBJ: RCRA Compliance Evaluation Inspection
Benjamin Moore and Company
EPA ID Number: ALD981472798

RCRA Inspection Report

Benjamin Moore and Company
109 Bamberg Drive
Pell City, Alabama 35125
St. Clair County
EPA ID: ALD981472798

June 26, 2019 at 10:00 a.m. CDT

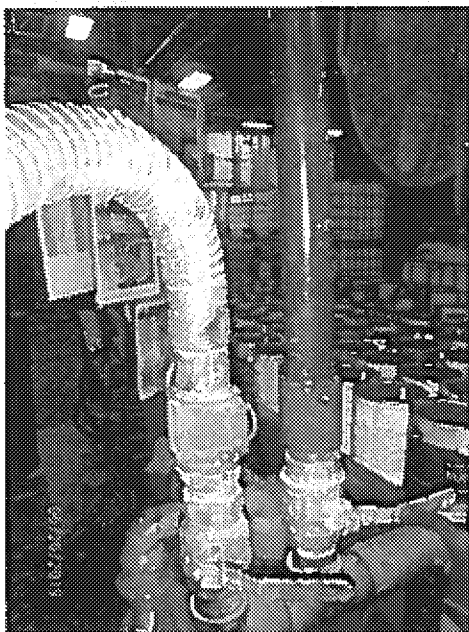
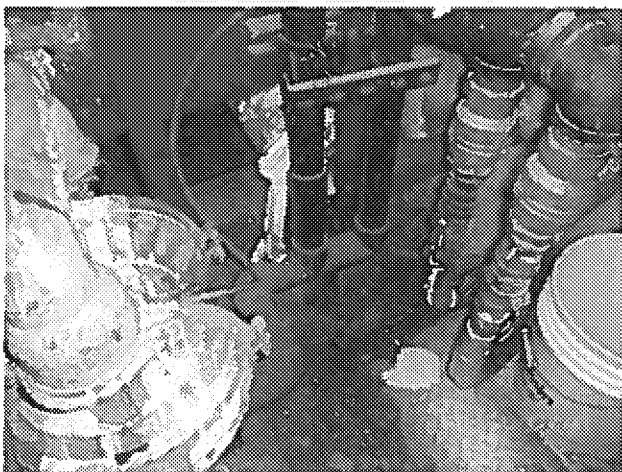
The inspectors observed that the Filling Line had four 55-gallon drums staged to capture the Alkyd fill tank flush (Picture 4). The dirty solvent flush lines were not marked (Pictures 1-3), but the lines are not currently connected to the hazardous waste tank which has been taken out of commission. Instead the dirty solvent is being piped in the 55-gallon drums. The drums were empty at the time of the inspection.

Picture 1 – Filling Line dirty solvent piping

Picture 2 – Filling Line dirty solvent piping

Picture 3 – Filling Line dirty solvent piping

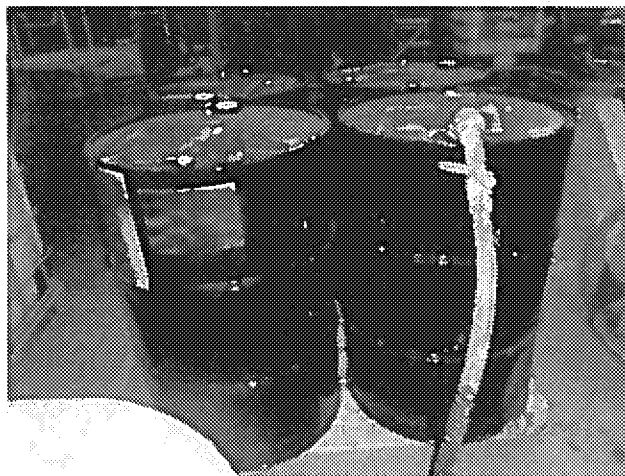
Picture 4 – Filling Line dirty solvent hose and empty drums

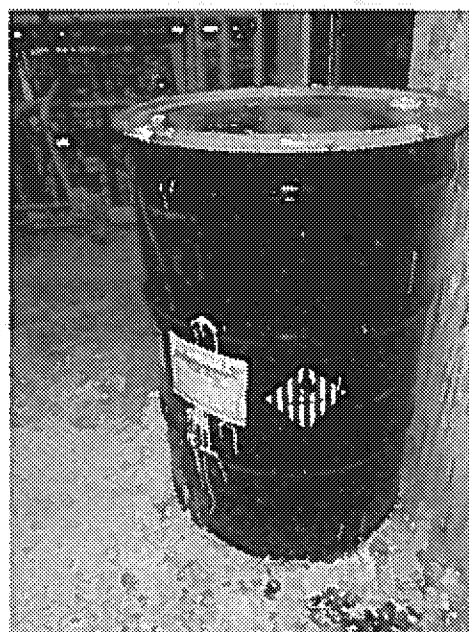
Above the Filling Line were the Fill Tower Tanks. The inspectors observed a 55-gallon satellite accumulation area (SAA) drum of hazardous waste filter bags (Pictures 5-6). The filter bags are generated from the changeover of paint formulations. The drum was closed and labeled. The inspectors also observed a 5-gallon container with a discarded hazardous waste filter bag inside (Pictures 7-8). Mr. Power explained that the 5-gallon containers are used to carry the dirty solvent filter bags to the drum and prevents releases to the area. However, the container was not labeled or closed.

Picture 5 – Filling Line IIW filter bag SAA

Picture 6 – Filling Line IIW filter bag SAA label

Pursuant to ADEM Admin. Code r. 335-14-3-.01(5)(a)4 [40 C.F.R. § 262.15(a)(4)], which is a condition of the SAA Permit Exemption, a generator is required to keep containers of hazardous waste closed at all times during accumulation, except when adding, removing, or consolidating waste; or when temporary venting of a container is necessary for the proper operation of equipment, or to prevent dangerous situations, such as build-up of extreme pressure.

Pursuant to ADEM Admin. Code r. 335-14-3-.01(5)(a)5 [40 C.F.R. § 262.15(a)(5)], which is a condition of the SAA Permit Exemption, a generator is required to mark or label its containers (i) with the words "Hazardous Waste" and (ii) with an indication of the hazards of the contents.

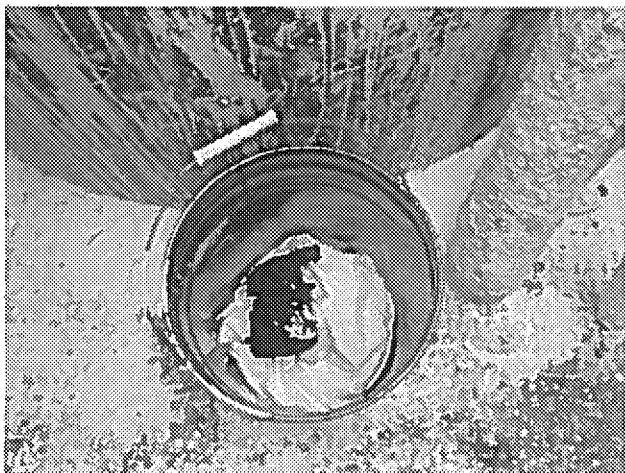
Picture 7 – Filling Line HW filter bag

Picture 8 – Filling Line HW filter bag

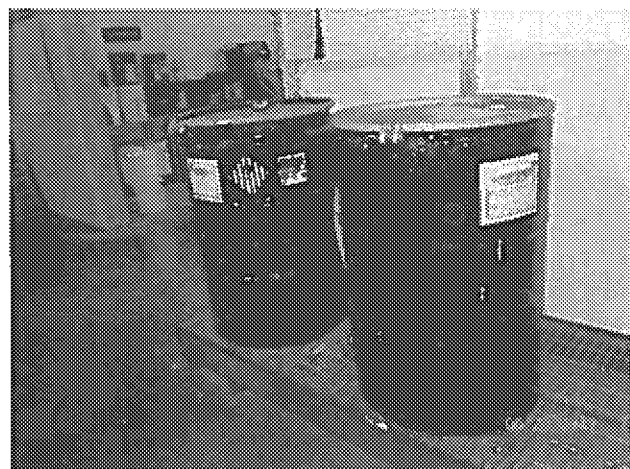
The inspectors observed the Small Batch Process, a smaller version of the main production area, that specializes in specific customer needs. The SAA contained a 55-gallon hazardous waste drum of paint filter bags and a 55-gallon hazardous waste drum of paint skins (Pictures 9-11). The drums were closed and labeled.

Picture 10 – Small Batch Process SAA

Picture 11 – Small Batch Process SAA

Picture 9 – Small Batch Process SAA

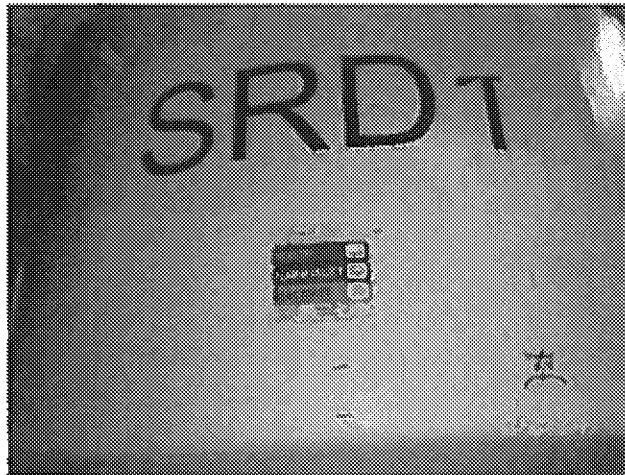
The main warehouse has final product stored in the center aisle and raw materials on the side aisles. This warehouse also houses the solvent tanks and the solvent still. The solvent recovery dirty tank, SRDI was disconnected from all piping receiving dirty solvent (Pictures 12-16). During the December 18, 2018, RCRA inspection by ADEM, the inspector, Mr. Corey Holmes, observed that the tank and its auxiliary connections were not tagged or monitored for leak detection, daily inspections were not conducted on the tank, the tank was not labeled as hazardous waste and the tank did not have an integrity test conducted by a professional engineer.

Mr. Power and Mr. Breckenridge explained to the inspectors that the company had a tank integrity test conducted and found that it was beneficial to discontinue use and disconnect the tank based on the engineering report. On February 22, 2019, Mr. Breckenridge notified ADEM via a mailed letter that the dirty solvent tank and ancillary equipment was taken out of service on February 19, 2019. Mr. Breckenridge stated that the contents of the tank and ancillary equipment were placed in drums and managed as hazardous waste in accordance with regulatory requirements.

A new tank has been ordered to replace the out of service tank. Mr. Power assured the inspectors that the new tank will be installed according to the RCRA tank requirements and monitored as required. However, prior to the December 18, 2018 compliance evaluation inspection and removing the tank and ancillary equipment from service in 2019, the requirements 40 C.F.R. Part 265 Subpart BB which is complying with the air emission standards for process vents and 40 C.F.R. Part 265 Subpart CC which is complying with the organic air emission standards, were not met.

Picture 12 – Warehouse Solvent Recovery Dirty tank

Picture 13 – Warehouse Solvent Recovery Dirty tank

Picture 14 – Warehouse Solvent Recovery Dirty tank piping

Picture 15 – Warehouse Solvent Recovery Dirty tank piping

Picture 16 – Warehouse Solvent Recovery Dirty tank label

Pursuant to ADEM Admin. Code r. 335-14-3-.01(7)(a)2. [40 C.F.R. § 262.17 (a)(2)], which incorporates ADEM Admin. Code r. 335-14-6-.27, .28 and .29 [Subparts AA, BB, and CC of 40 CFR Part 265], and is a condition of the LQG Permit Exemption, a generator is required to

comply with applicable organic air emission standards for tanks.

Pursuant to ADEM Admin. Code r. 335-14-3-.01(7)(a)2. [40 C.F.R. § 262.17(a)(2)], which incorporates ADEM Admin. Code r. 335-14-6-.28 [40 C.F.R. Part 265, Subpart BB], and is a condition of the LQG Permit Exemption, a generator accumulating hazardous waste in tanks must comply with the RCRA Subpart BB organic air emission standards for equipment leaks, including, but not limited to the recordkeeping requirements in ADEM Admin. Code r. 335-14-6-.28 [40 C.F.R. § 265.1064].

Pursuant to ADEM Admin. Code r. 335-14-3-.01(7)(a)2. [40 C.F.R. § 262.17(a)(2)], which incorporates ADEM Admin. Code r. 335-14-6-.29 [40 C.F.R. Part 265, Subpart CC] and is a condition of the LQG Permit Exemption, a generator accumulating hazardous waste in tanks must comply with the RCRA Subpart CC organic air emission standards for tanks, including, but not limited to the recordkeeping requirements in ADEM Admin. Code r. 335-14-6-.29 [40 C.F.R. § 265.1090].

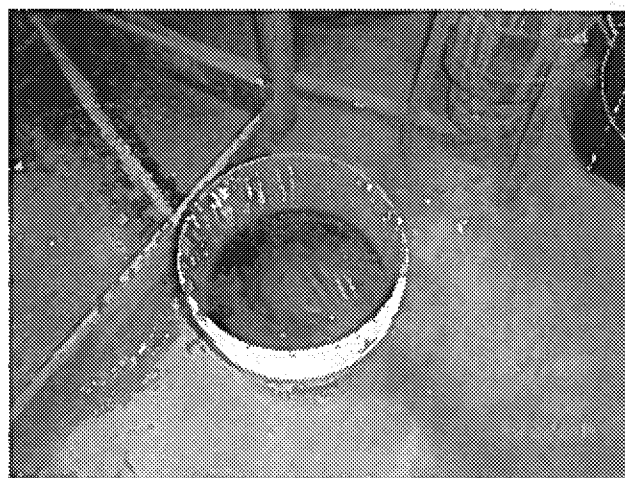
At the time of the inspection, the inspectors observed two 5-gallon containers of unidentified contents. The containers were not closed or labeled. Mr. Power and Mr. Breckenridge were not aware of the contents.

Picture 17 – Distillation unidentified container 1

Picture 18 – Distillation unidentified container 1

Picture 19 – Distillation unidentified container 2

Pursuant to ADEM Admin. Code r. 335-14-3-.01(2) [40 C.F.R. § 262.11], a person who generates a solid waste, as defined in ADEM Admin. Code r. 335-14-2-.01(2) [40 C.F.R. § 261.2], must make an accurate determination as to whether that waste is a hazardous waste in order to ensure wastes are properly managed according to applicable RCRA regulations.

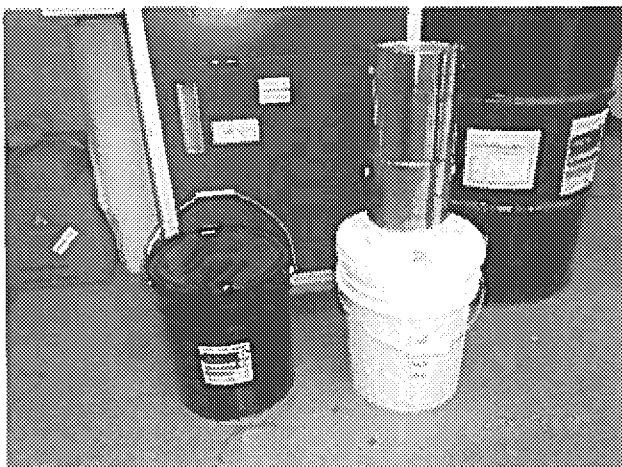
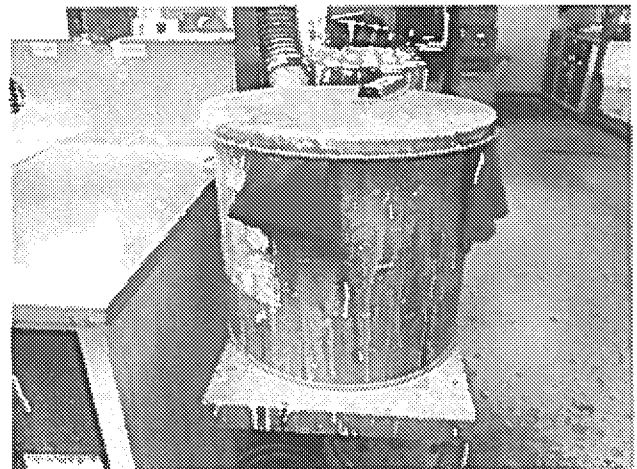
The Low Flash Lab is a separate room that provides quality control for the solvent based paints. There were multiple SAA in the Low Flash Lab. The inspectors observed a black 55-gallon SAA of hazardous waste alkyd clean up material, a white 5-gallon container of latex waste, two silver one-gallon containers of latex waste, a black 5-gallon container of lab waste that did not have hazardous waste label (Pictures 20-22), a cart with spent aerosol cans to be punctured that were not labeled (Picture 23), and a red fire can of xylene used for cleaning paint brushes (Picture 24).

Picture 22 – Low Flash Lab SAA drum label

Picture 20 – Low Flash Lab SAA drum

Picture 23 – Low Flash Lab spent aerosol cans

Picture 21 – Low Flash Lab SAA, non-HW containers and unidentified container

Picture 24 – Low Flash Lab xylene cleaning container

Pursuant to ADEM Admin. Code r. 335-14-3-.01(5)(a)5 [40 C.F.R. § 262.15(a)(5)], which is a condition of the SAA Permit Exemption, a generator is required to mark or label its containers (i) with the words "Hazardous Waste" and (ii) with an indication of the hazards of the contents.

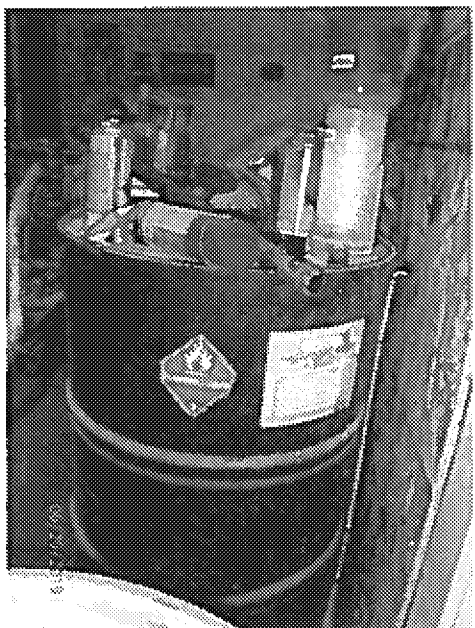
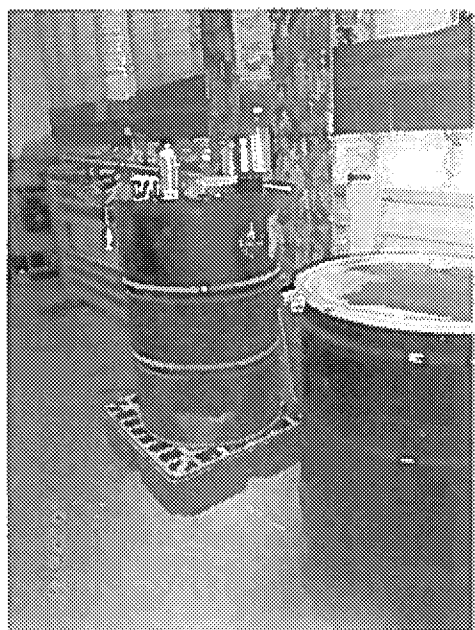
The 55-gallon SAA drum of spent aerosol residue was in the Caustic Wash area (Pictures 25-26). The drum had an aerosol can puncture system attached to the bung and aerosol cans and debris stored on top. The drum was observed to be closed and labeled.

Picture 25 -- Caustic Wash aerosol can puncture system and drum

Picture 26 -- Caustic Wash aerosol can puncture system and drum

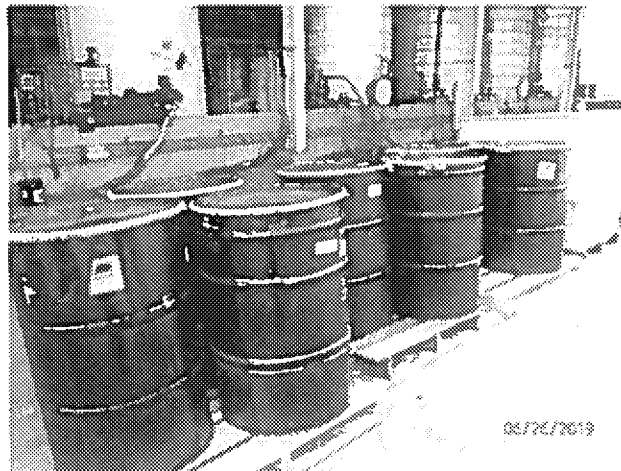
At the time of the inspection, six 55-gallon used oil drums and two 55-gallon drums of sprinkler water were staged near the tank farm waiting for pickup (Picture 27). The drums had been staged since June 25, 2019, but the transporter had not yet arrived to pump the oil out of the drums. The used oil drums are normally stored in the non-hazardous waste area of the CAA. The used oil was generated from the air compressor.

Picture 27 -- Used oil drums staged

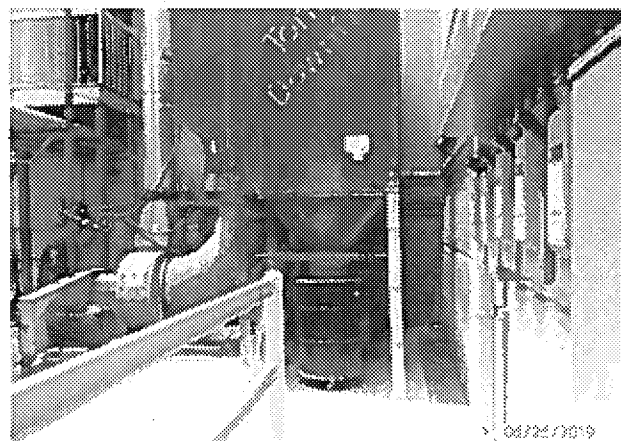
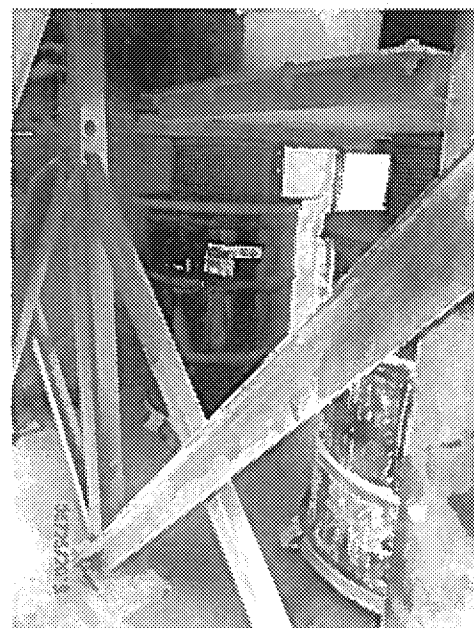
During the tour, the inspectors observed an outside baghouse. Mr. Power explained that the facility has five baghouse hoppers for pigment dust. The baghouse the inspectors observed had three hoppers with 55-gallon drums underneath (Pictures 28-29). The pigment dust is disposed of as non-hazardous waste.

Picture 28 -- Pigment Dust Baghouse and drums

Picture 29 -- Pigment Dust Baghouse drums
